Waikato Building Reports

46 Hamilton Gardens Obdam

Summary

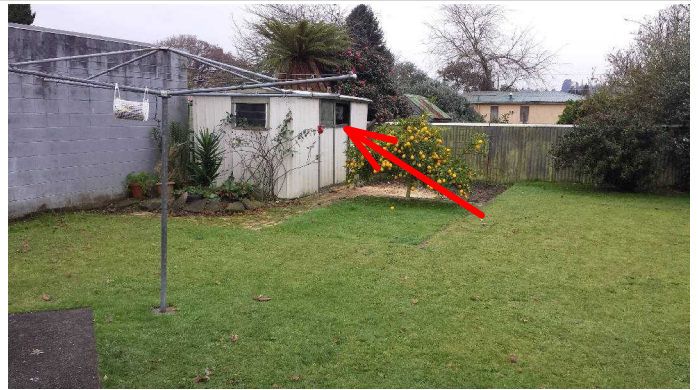
1. Garden Sheds: Small garden shed - Glass missing

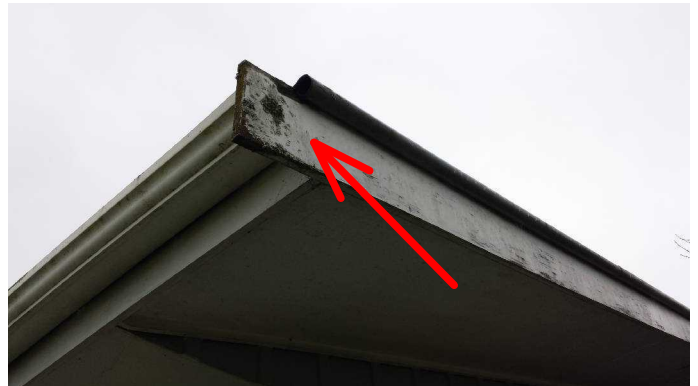
2. Fascia: Painted timber - Paint peeling on most of the fascia boards

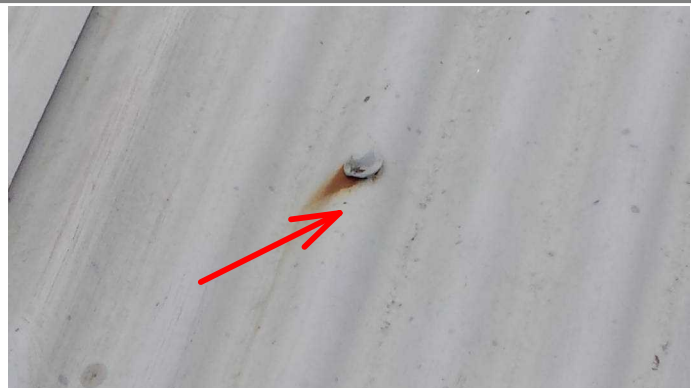
3. Roof Material: Painted iron - Some loose nails.

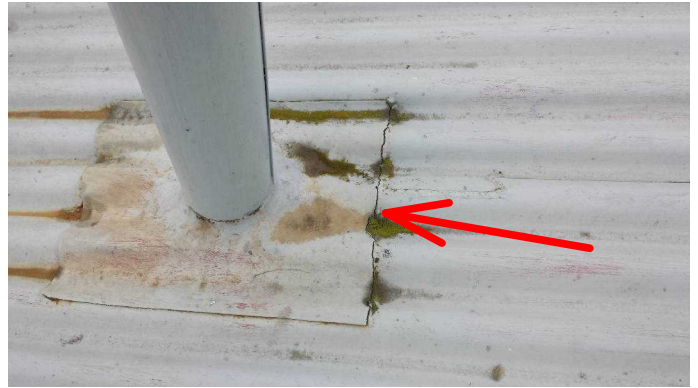
4. Flashings: Lead - Cracked flashing behind the vent pipe

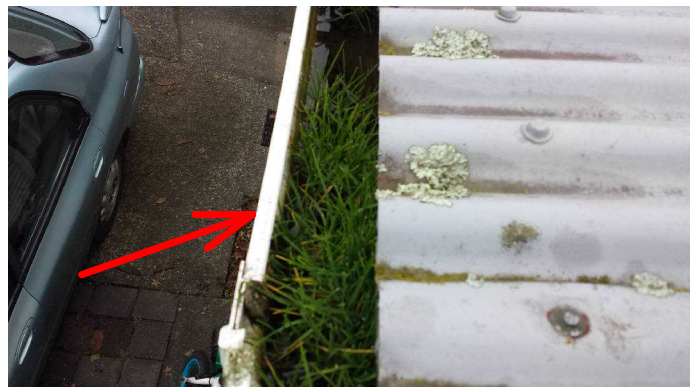
5. Gutters: PVC - Gutters have negative flow and are holding water. Needs cleaning.

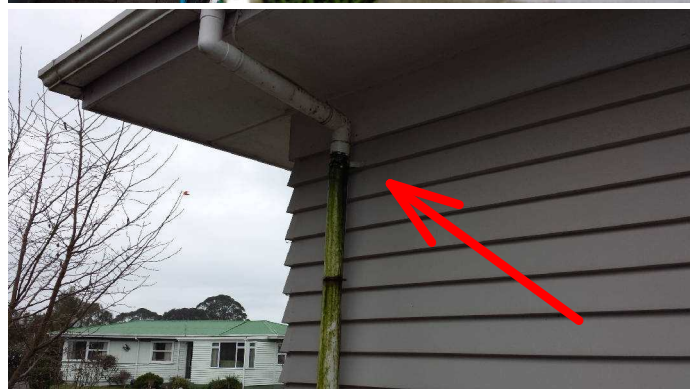
6. Downpipes: PVC - Downpipe appears blocked or is seriously leaking outside kitchen

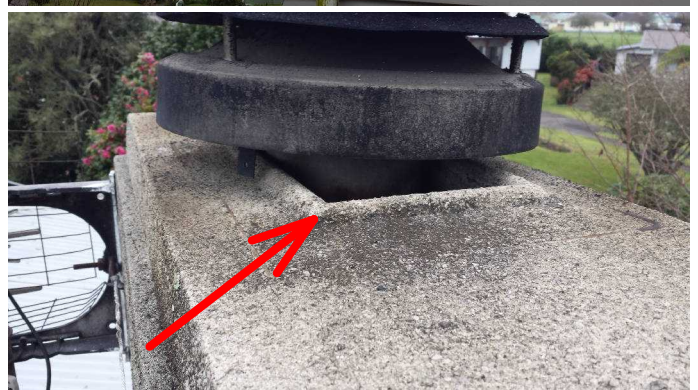
7. Flue: Metal - There should be a protective cover over the hole in the precast section to prevent water getting into the cavity space.

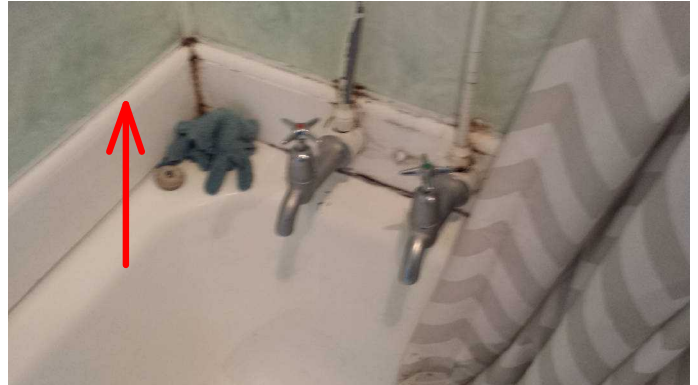
8. Off hallway Bathroom Walls: Gib board, Water proof lining
- I suspect that the timber around the edge of the bath is very wet and there is a strong possibility that water from the shower is running between the wall lining and behind at this timber

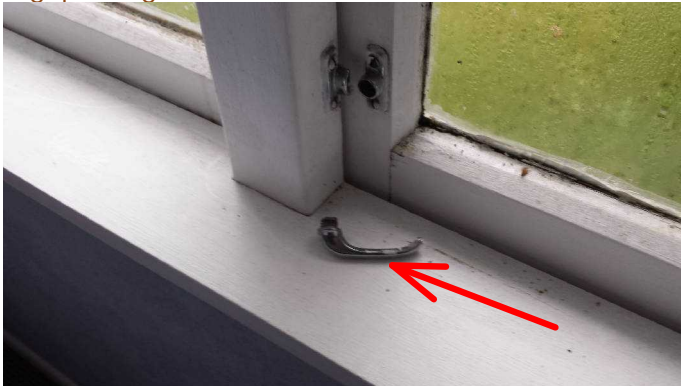
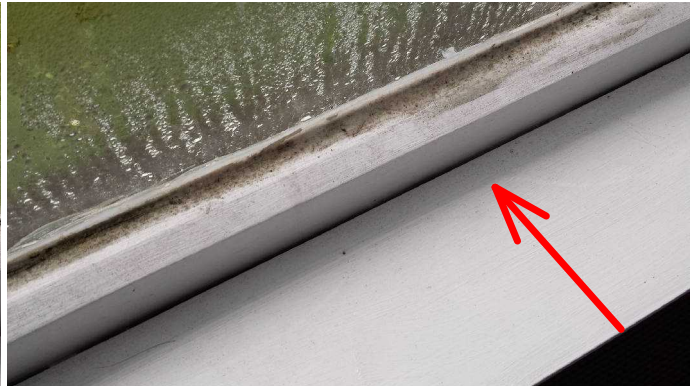
9. Off hallway, 3 bedrooms Bedroom Windows: Timber framed, Single glazed - In the main bedroom window that faces the street the window latches are broken and the large section of window appears to be loose as there is a gap along the windowsill and the timber window frame

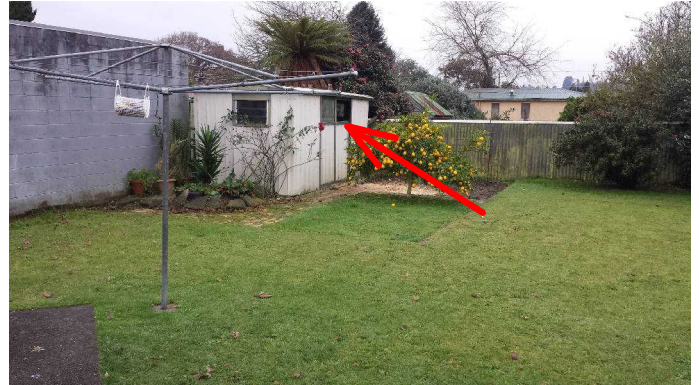
| 7. Marginal | Garden Sheds: Small garden shed - Glass missing |

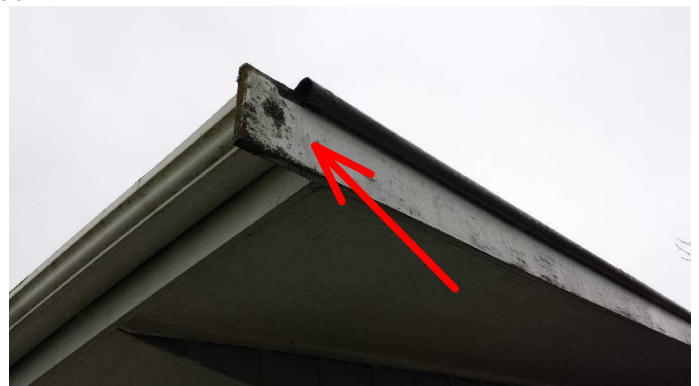
| 5. Marginal | Fascia: Painted timber - Paint peeling on most of the fascia boards |

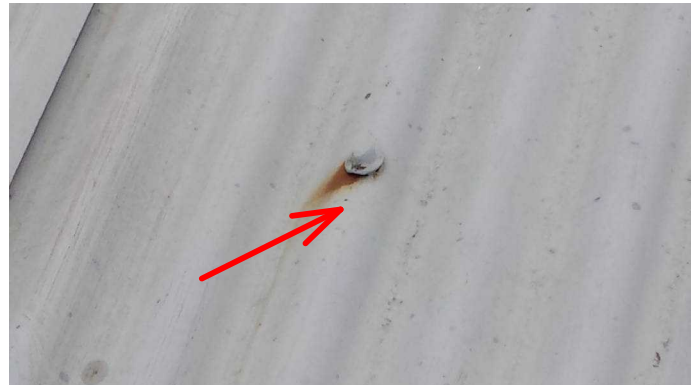
1. Marginal Roof Material: Painted iron - Some loose nails.

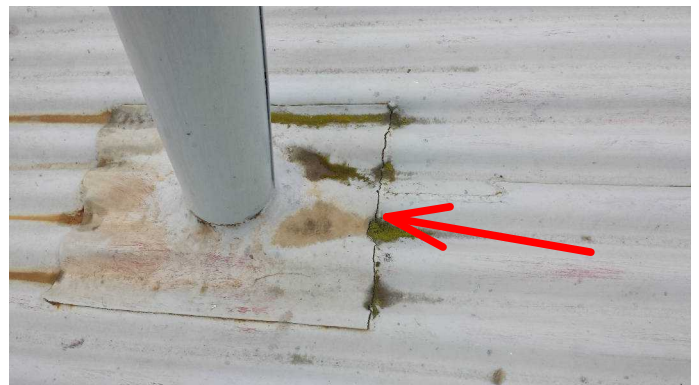
2. Marginal Flashings: Lead - Cracked flashing behind the vent pipe

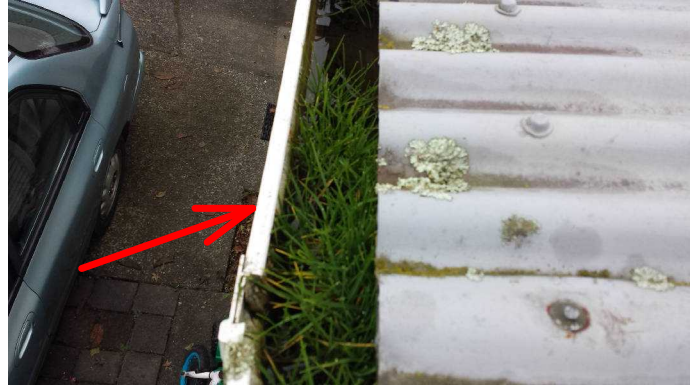
Gutters: PVC - Gutters have negative flow and are holding water. Needs cleaning.

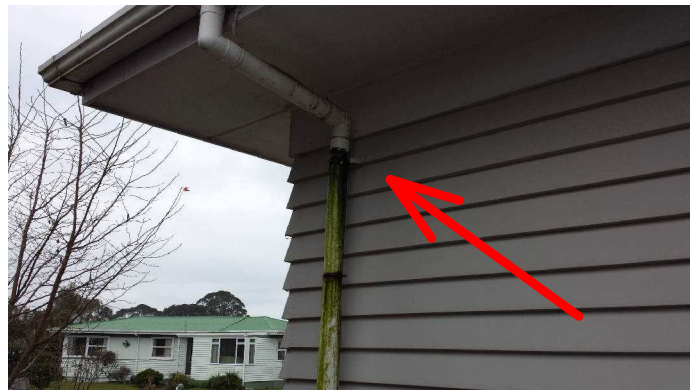
Downpipes: PVC - Downpipe appears blocked or is seriously leaking outside kitchen

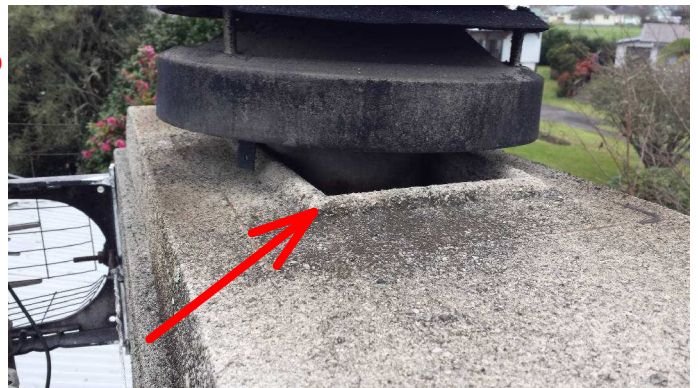
Flue: Metal - There should be a protective cover over the hole in the precast section to prevent water getting into the cavity space.

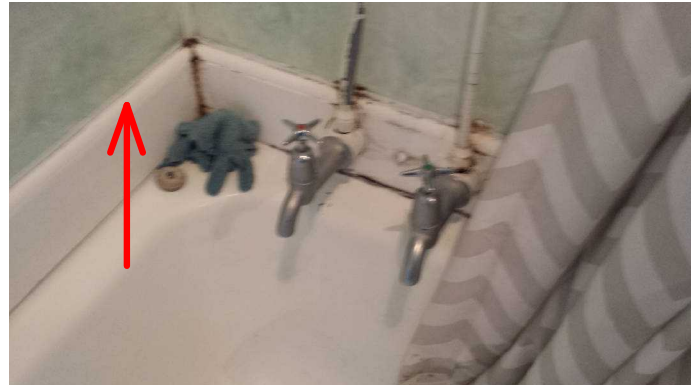
- 1. Acceptable Ceiling: Gib board
- 2. Marginal Walls: Gib board, Water proof lining - I suspect that the timber around the edge of the bath is very wet and there is a strong possibility that water from the shower is running between the wall lining and behind at this timber

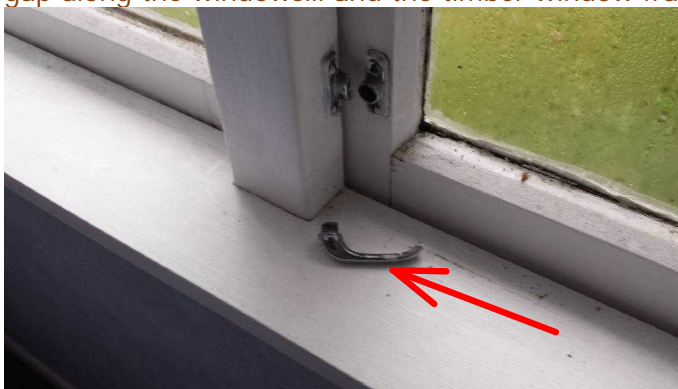
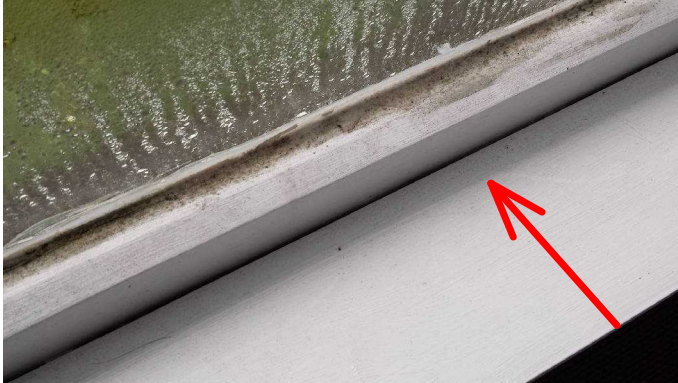
| 6. Marginal | Windows: Timber framed, Single glazed - In the main bedroom window that faces the street the window latches are broken and the large section of window appears to be loose as there is a gap along the windowsill and the timber window frame |
