Waikato Building Reports

46 Hamilton Gardens Obdam

Summary

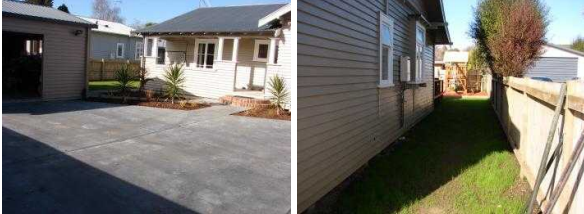
- 6. Acceptable Soffits: Cement board
- 7. Acceptable Exterior Lighting: Surface mount
- 8. General Photos: .

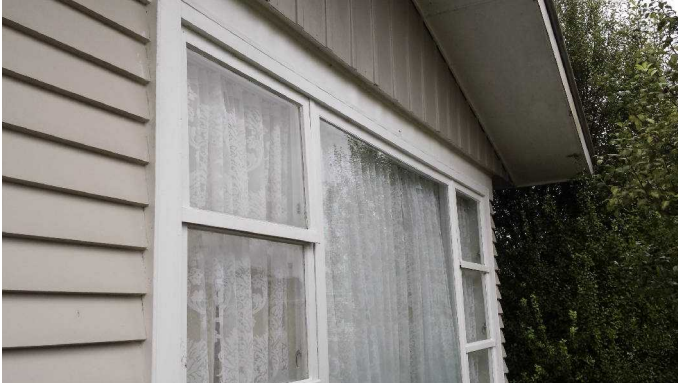
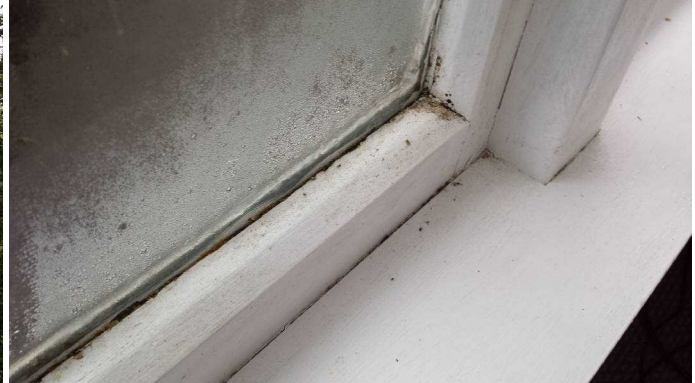
- 1. Acceptable Main Doors: Timber with glass panes
- 2. Acceptable Other Doors: Timber with glass panes
- 3. Acceptable Windows: Timber framed, Single glazed
- 4. Acceptable Flashings Painted timber
- 5. Acceptable Safety latches Fitted to some windows
- 6. General Photos: .

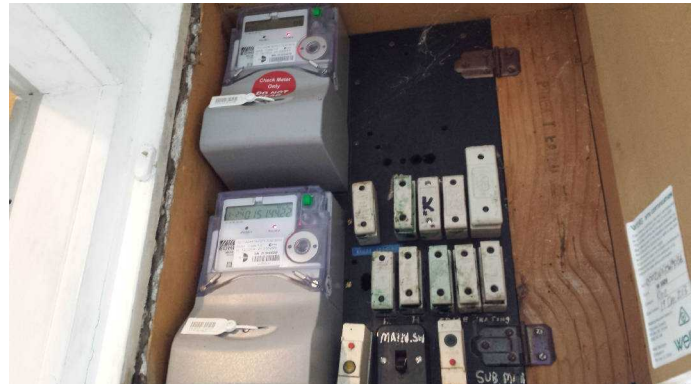
1. Acceptable Cable Type: TPS, Underground supply from pole
2. Acceptable Meterbox: Timber type, Located outside by back door
3. Acceptable Fuse Board: With meterbox
4. General Photos: .

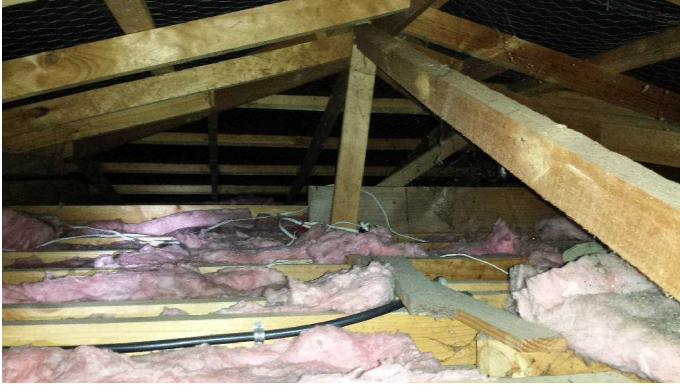
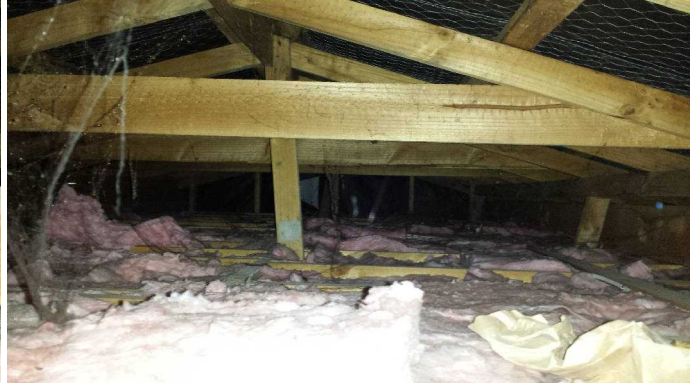
Ceiling Space (Continued)

1. Method of Inspection: From the manhole access
2. Acceptable Manhole location: Hallway
3. Acceptable Roof Framing: Timber pitched
4. Acceptable Ventilation: Roof only
5. Acceptable Insulation: Batts
6. Acceptable Insulation Depth: Below top of ceiling joist
7. Acceptable Wiring/Lighting: Wiring is draped across ceiling joists
8. Acceptable Moisture Penetration: None sighted
9. Acceptable Bathroom Venting: None
10. Acceptable Kitchen Rangehood: None

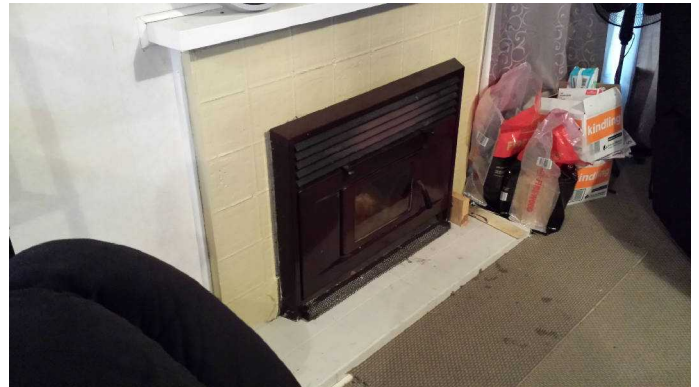
1. Acceptable Fireplace Construction: Steel
2. Acceptable Fireplace Insert: Steel firebox
3. Acceptable Flue: Metal
4. Acceptable Hearth: Tiled
5. General Photos: .

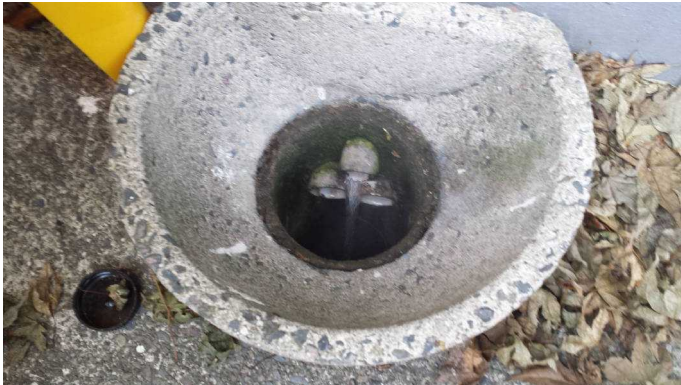
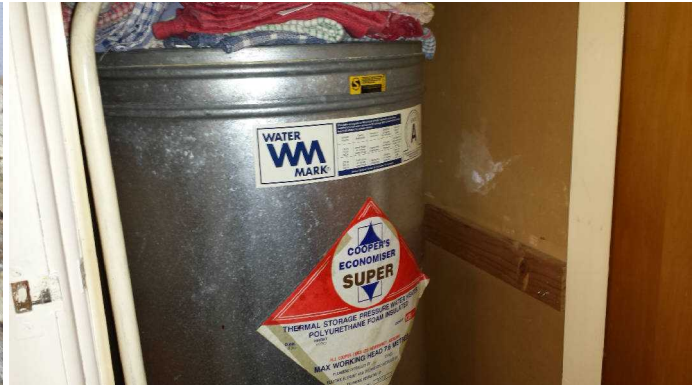
Hallway Water Heater

6. Acceptable Water Heater Operation: Adequate
7. Manufacturer: Coopers
8. Restrained No
9. Age: About 25 years old
10. Type: Electric, Low pressure Capacity: 135 litre
11. General Photos: .

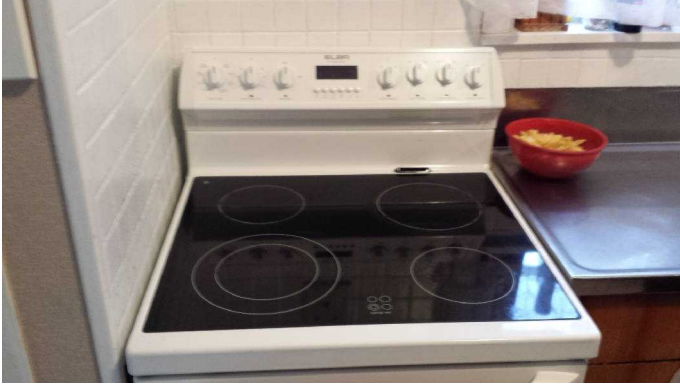
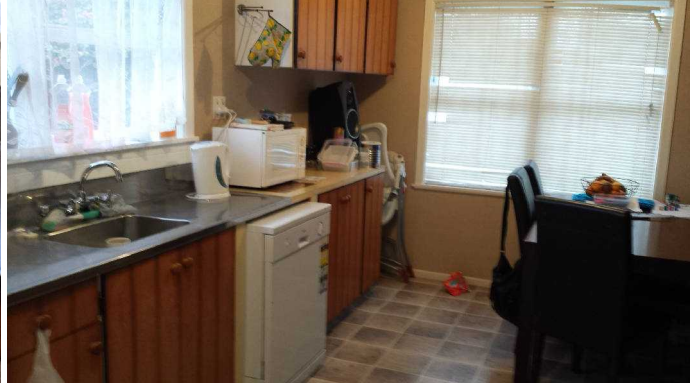
Kitchen (Continued)

1. Acceptable Cooking Appliances: Fisher & Paykel, Free standing
2. Acceptable Rangehood: No Rangehood
3. Acceptable Waste Disposal: No waste disposal
4. Acceptable Dishwasher: Haier
5. Acceptable Sink: Stainless Steel single bowl
6. Acceptable Electrical: No issues found
7. Acceptable Taps and wastepipes: Faucet, PVC waste pipe
8. Acceptable Benchtops: Stainless steel, Formica
9. Acceptable Units/Cabinets: Original painted timber
10. Acceptable Ceiling: Gib board, Texture paint
11. Acceptable Walls: Gib board
12. Acceptable Floor: Vinyl over timber
13. Acceptable Windows: Timber framed, Single glazed

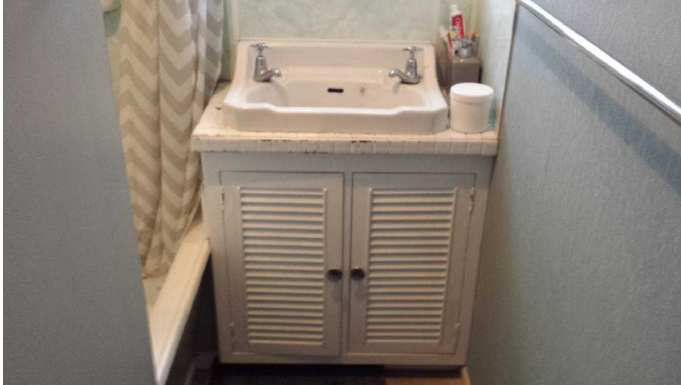
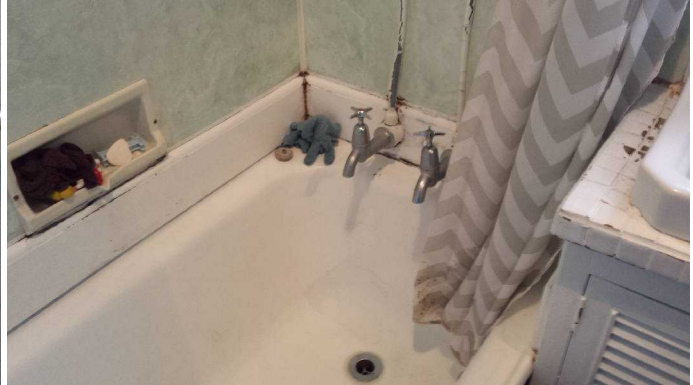
Bathroom (Continued)

- 3. Acceptable Floor: Vinyl over timber
- 4. Acceptable Doors: Hollow core
- 5. Acceptable Windows: Timber framed, Single glazed
- 6. Acceptable Electrical: No issues found
- 7. Acceptable Vanity Unit: Original painted timber
- 8. Acceptable Sink/Basin: Porcelain coated
- 9. Acceptable Taps and wastepipes: Individual taps, Copper trap
- 10. Acceptable Bath: Poreclin over steel
- 11. Acceptable Shower: Shower over the bath
- 12. Acceptable Heat Lamps/ Lights Standard lights
- 13. Acceptable Toilets: Separate main toilet

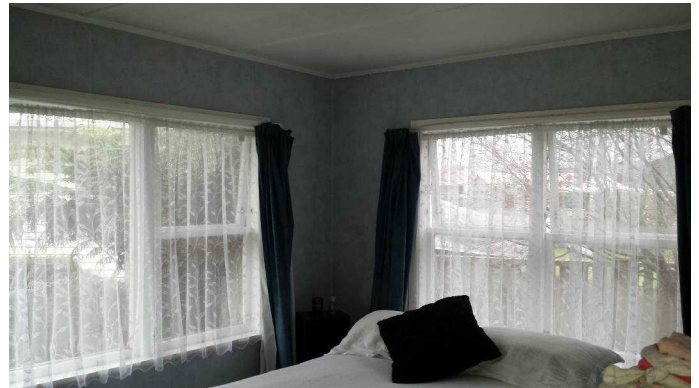
- 7. Acceptable Electrical: Some lights bulbs broken
- 8. Acceptable Smoke Detector: None
- 9. General Photos: .

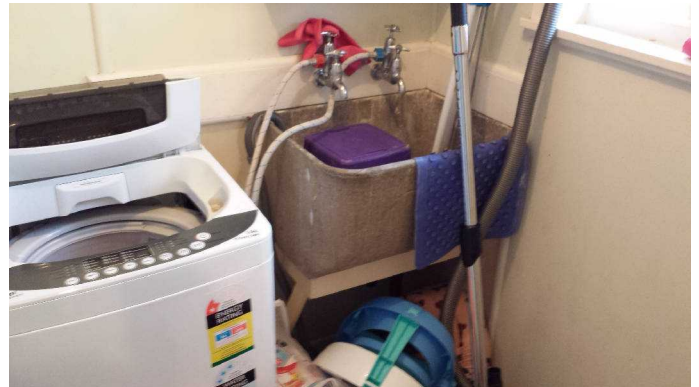
1. Acceptable Ceiling: Gib board
2. Acceptable Walls: Gib board
3. Acceptable Floor: Vinyl over timber
4. Acceptable Doors: Timber
5. Acceptable Windows: Timber framed, Single glazed
6. Acceptable Electrical: No issues found
7. Acceptable Smoke Detector: None
8. Acceptable Laundry Tub: Concrete
9. Acceptable Laundry Tub Drain: Copper
10. Acceptable Taps Individual taps
11. Acceptable Washer Drain: Drains into laundry tub
12. General Photos: .

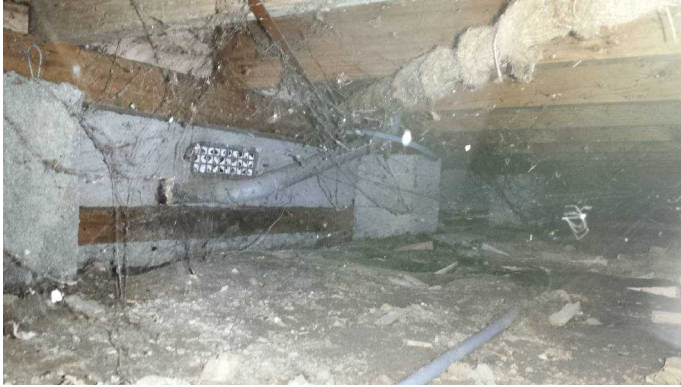
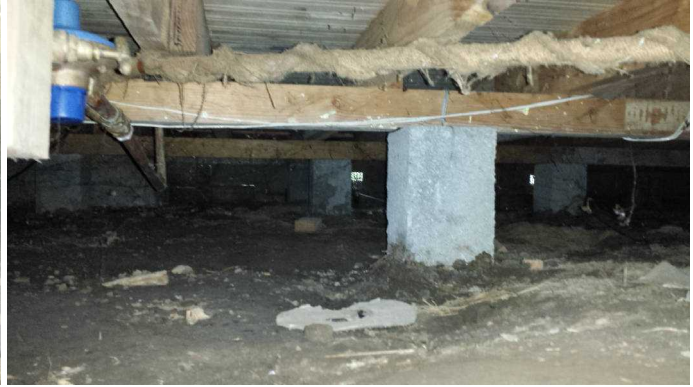
1. Method of Inspection: In the crawl space
2. Acceptable Access: Wood door
3. Acceptable Floor type: Native timber
4. Acceptable Moisture Barrier: None
5. Acceptable Bearers & Joists Native timber
6. Acceptable Pile type: Concrete
7. Acceptable Ventilation: Grills in fibrolite base cladding
8. Acceptable Insulation: None

9. Acceptable Waste Pipes: Mixture of both PVC and copper
